**Reconnaissance Following the October 15th, 2006
Earthquakes on the Island of Hawai'i**

**UNIVERSITY OF HAWAII
COLLEGE OF ENGINEERING**

Research Report UHM/CEE/06-07

October 26, 2006

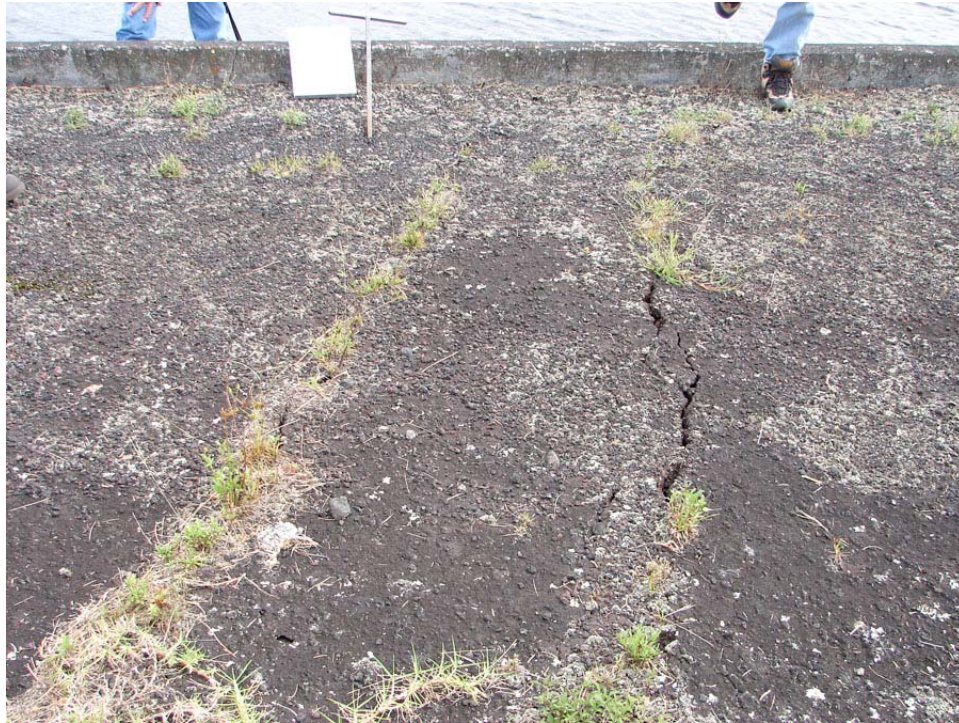
Two transverse cracks on the crest of the embankment, separated by 3 to 4 feet, were each about ½ inch wide and of unknown depth (Figure 50). The area between these cracks was noticeably softer than adjacent portions of the embankment. Joints between some of the concrete panels opened up somewhat. Some spalling was noted along the upper lip of the concrete lining (Figure 51). Seepage through the embankment was known to occur from prior surveys. Our inspection did not reveal any additional seepage from the reservoir through the embankment that may have been associated with the earthquake. Inlet and outlet structures seemed to have fared well.

Figure 50: Transverse crack on embankment top (D1).

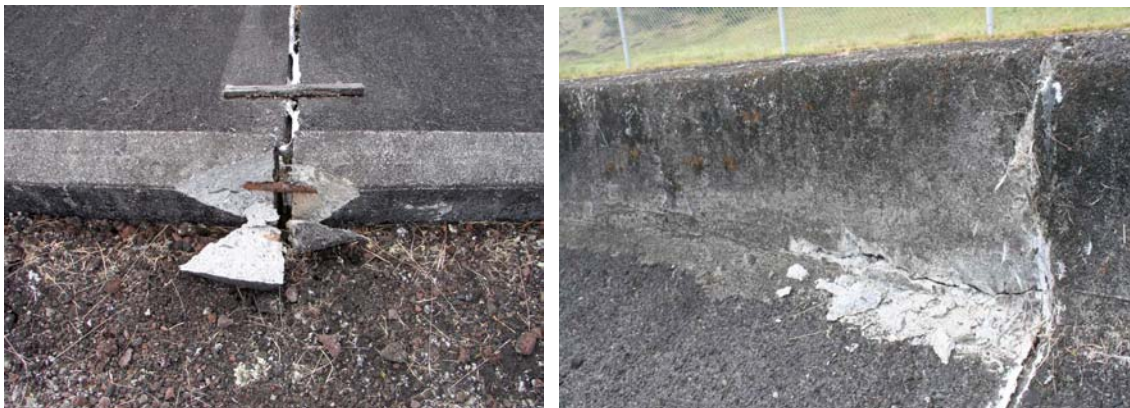
Figure 51: Concrete spalling, cracking and opening of panel joints (D1).

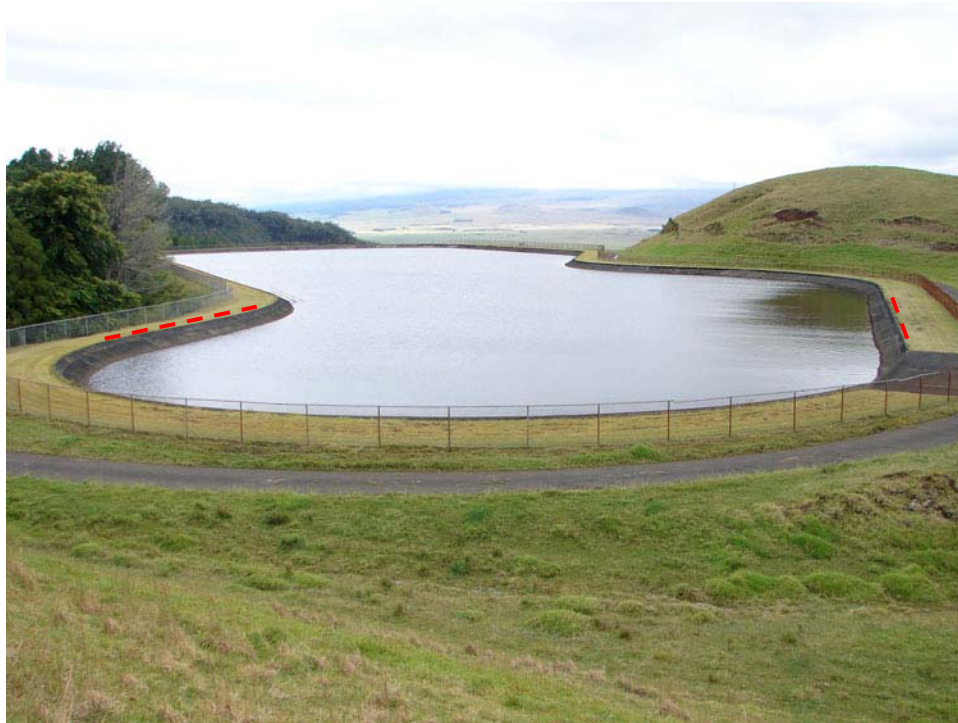
Similar observations were made with regard to the adjacent Waikoloa I reservoir (Figure 52), but signs of severe shaking were significantly less. There was some fill disturbance near the top of the concrete lining, but only along two 50 foot-long sections on opposite sides of the pool. The other reservoirs in the series showed no evidence of significant damage. The water treatment plant below the reservoirs did show some distress, consisting chiefly of cracks in soil slopes, some ruptured PVC pipes and shifting/cracking of concrete works.

Figure 52: Waikoloa I reservoir indicating extent of observed fill disturbance (D1).

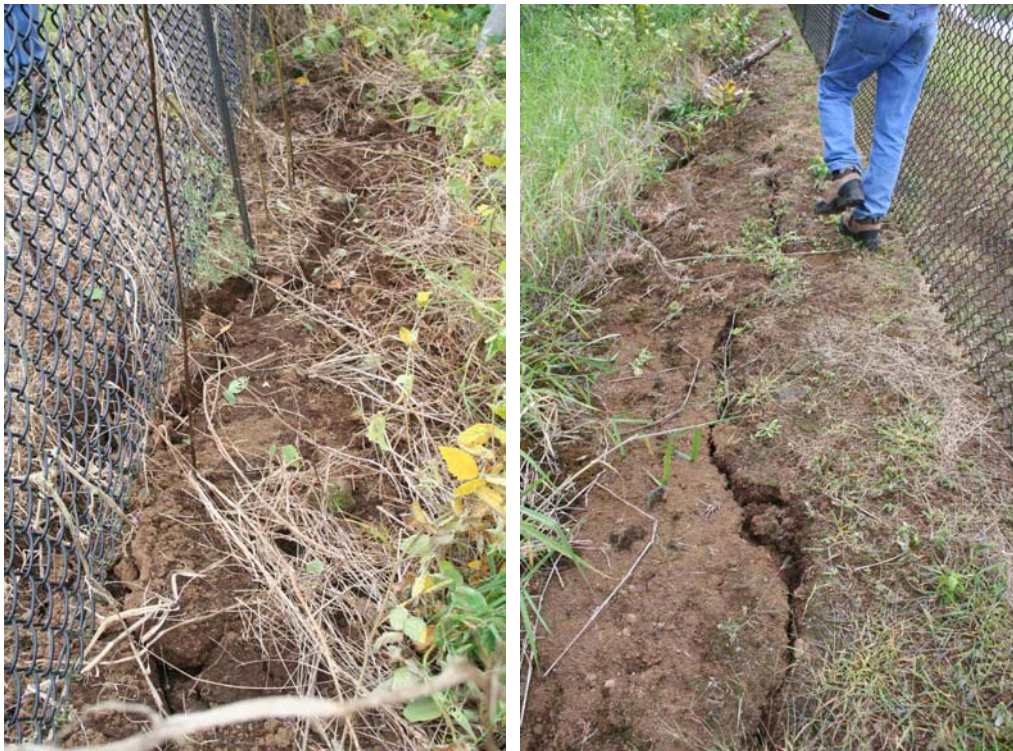
Figure 54: Cracks in crest of Puu Pulehu embankment (D2).

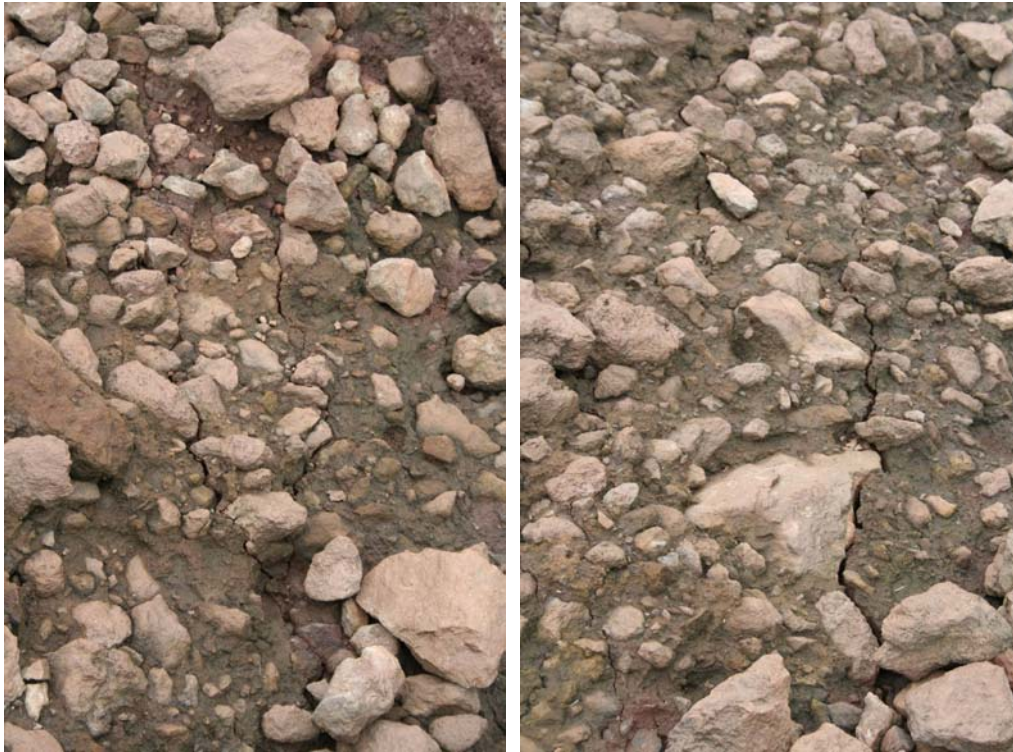
Figure 57: Cracks in reservoir embankment beneath rip-rap (D3).

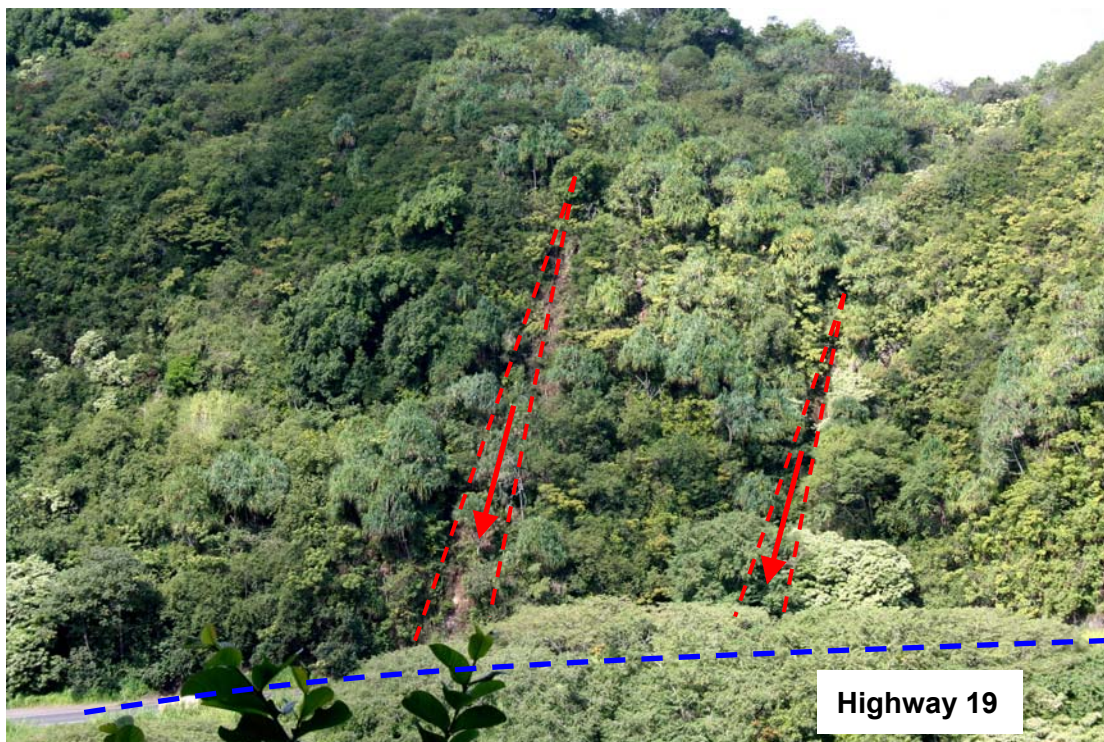
Figure 58: Long, narrow slides on natural slope above roadway (R1).

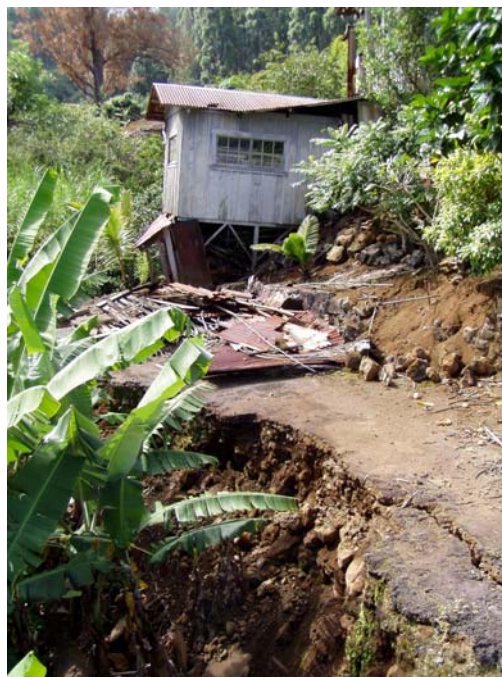
Figure 59: Slide near damaged residence on Hamakua Coast (R2).

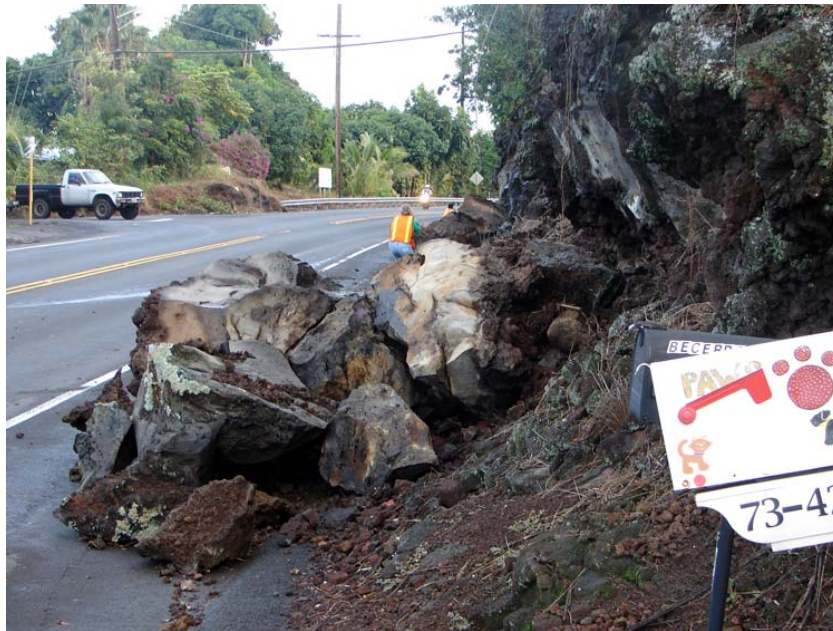
Figure 60: Rockfall in road cut at mile 35.5 on Highway 190 (R3).

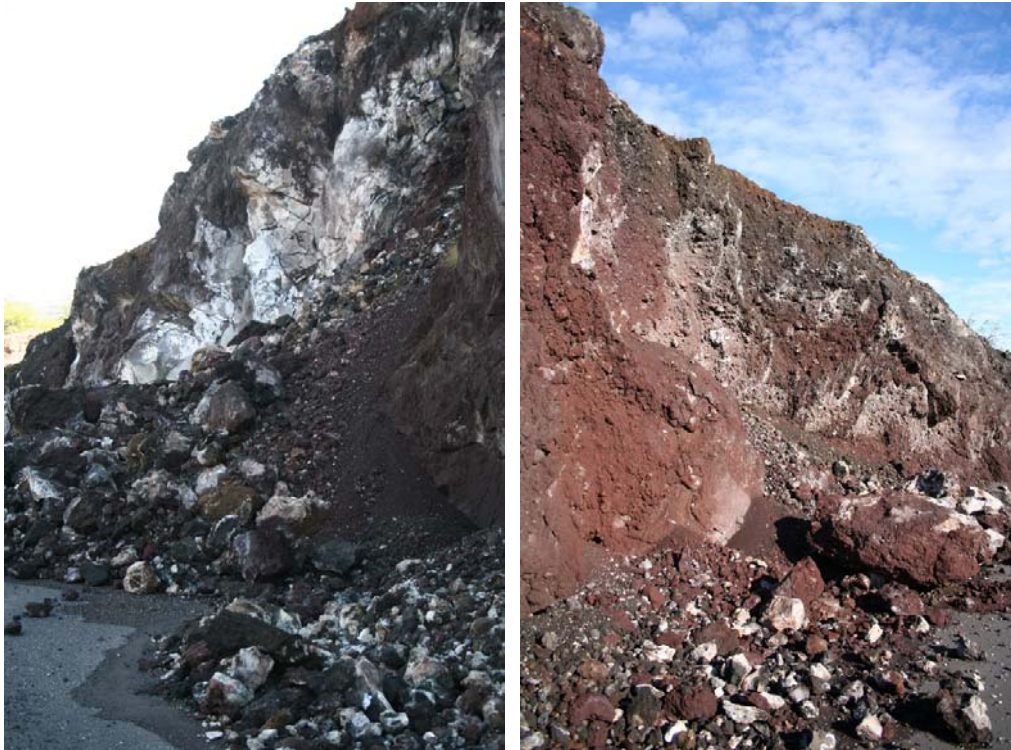
Figure 61: Rockfalls on road cuts along Highway 19 North of Kailua-Kona (R4).

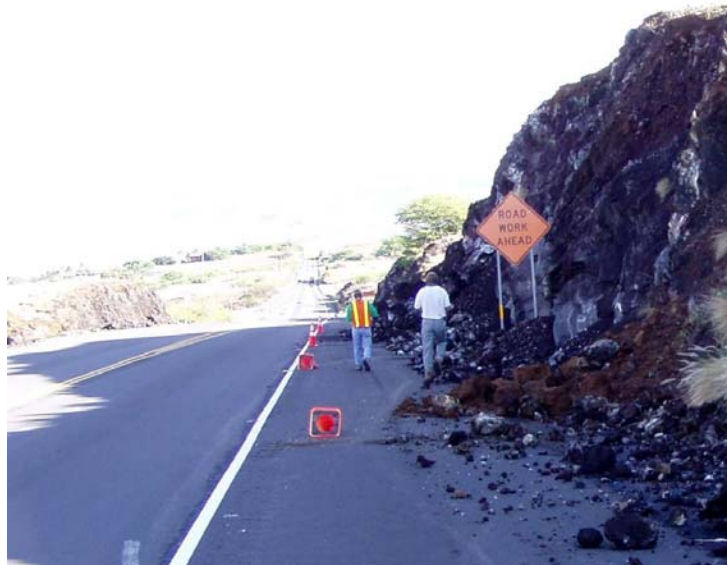
Figure 64: Rockfall onto shoulder of Highway 19 North of Kailua-Kona (R6).

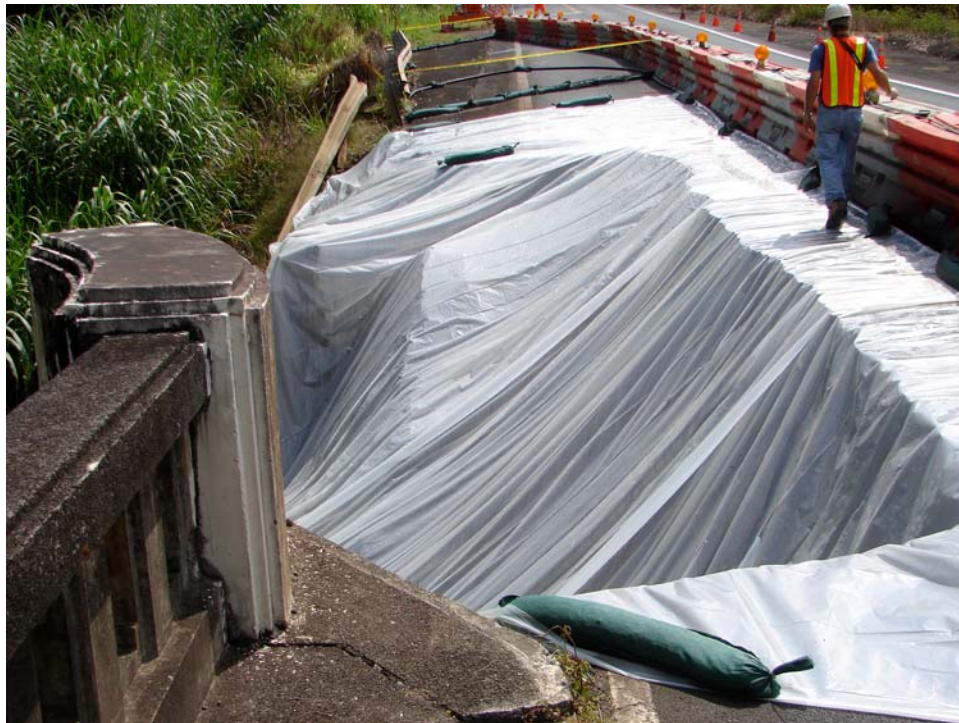
Figure 65: Collapse of Highway 19 embankment on approach to bridge (R7).

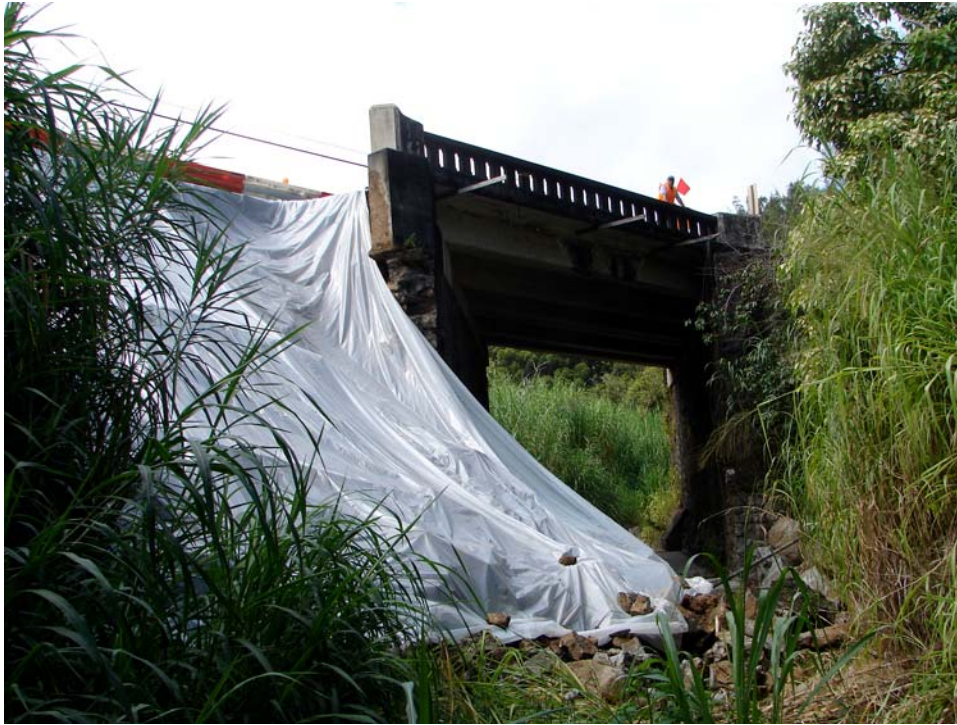
Figure 66: Collapsed abutment wing wall (R7).

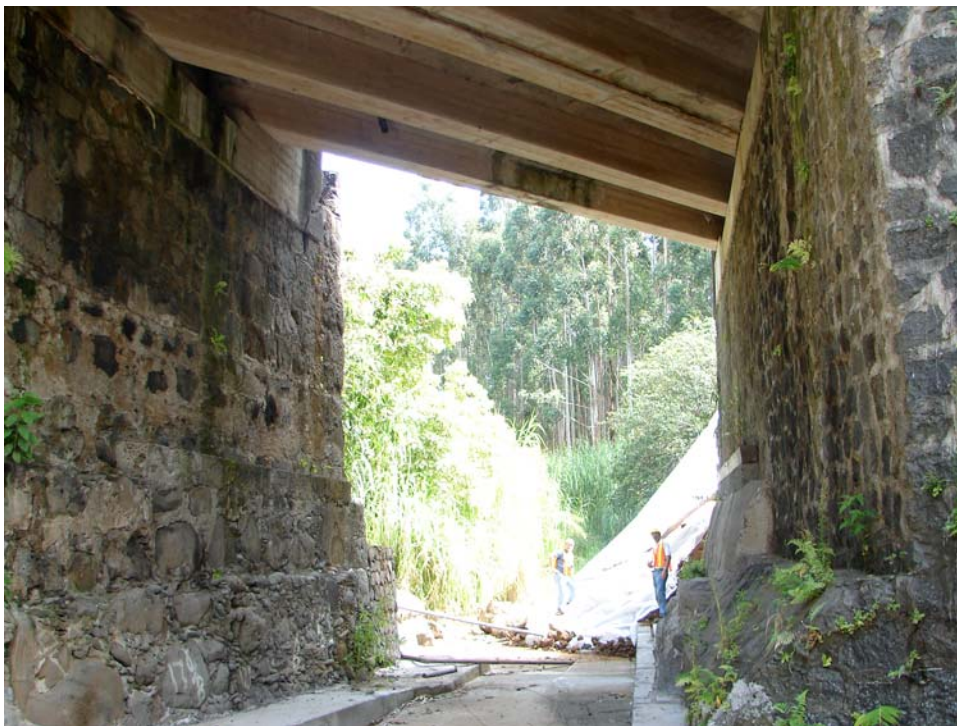
Figure 67: Collapse occurred around the right rear corner of rock wall abutment (R7).

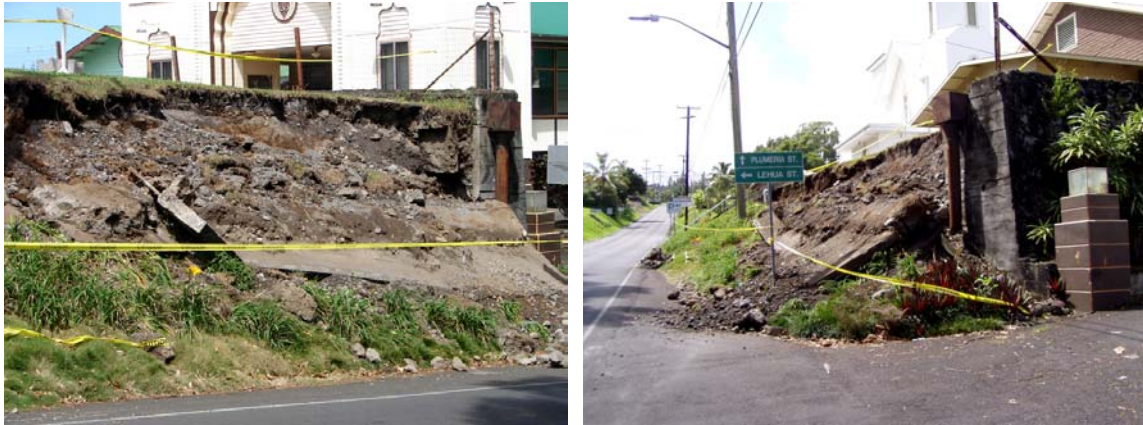
Figure 70: Collapse of concrete retaining wall with inadequate footing in Honokaa (R8).

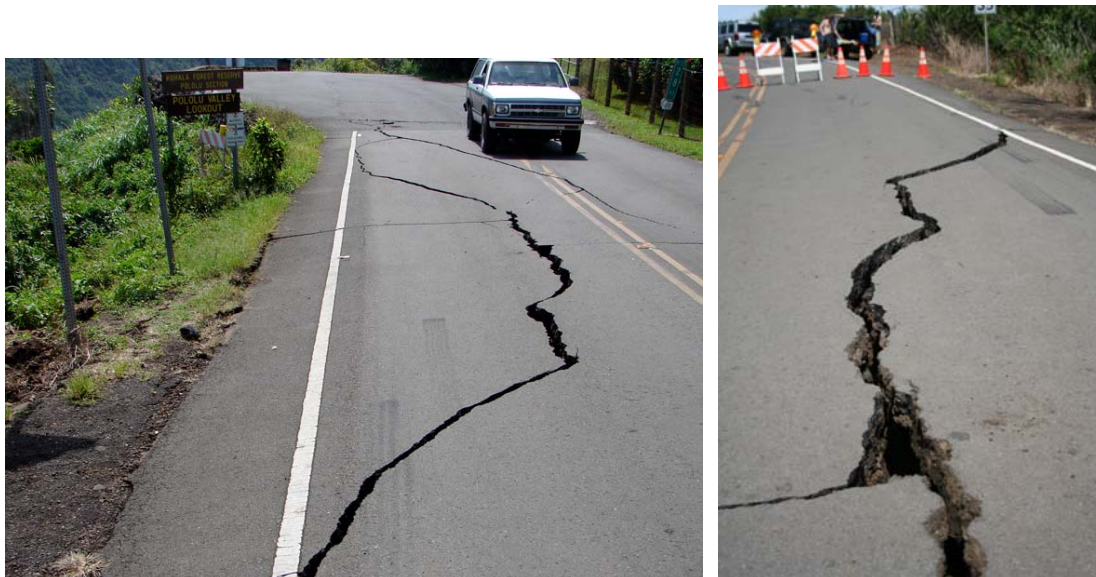
Figure 71: Cracks at Pololu lookout due to lateral sliding of road toward steep slope (R9).

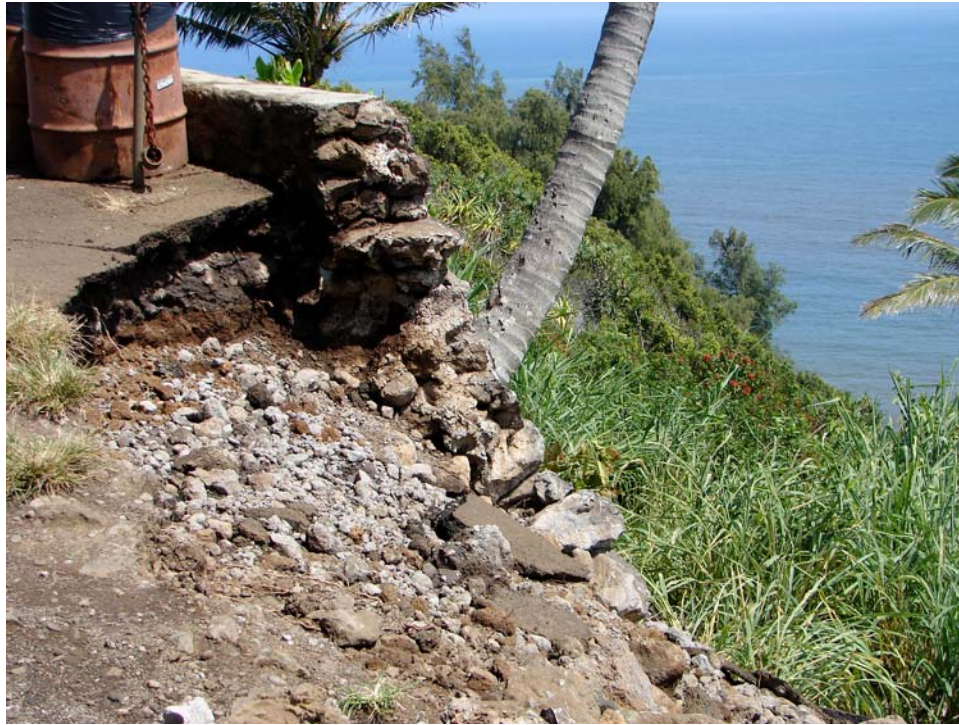
Figure 72: Collapsed rock wall at end of Pololu lookout parking lot (R9).

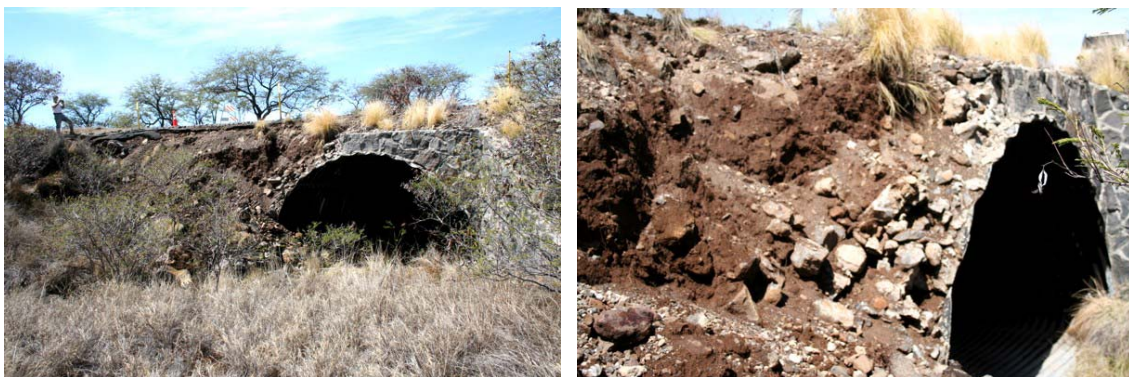
Figure 73: Failed highway embankment and rock wing wall adjacent to culvert (R10).

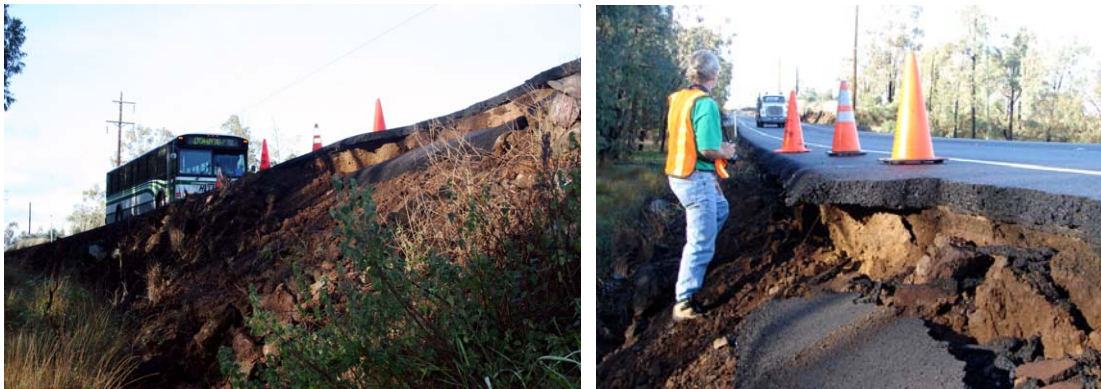
Figure 75: Embankment and asphalt collapse at mile 13 on Highway 190 (R11).

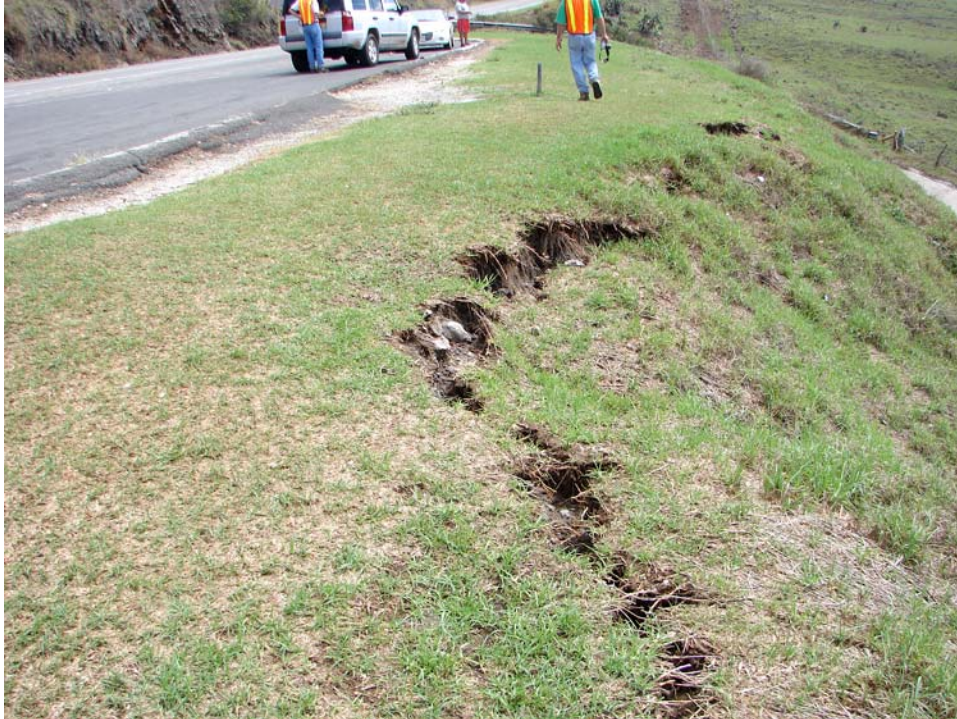
Figure 76: Incipient sliding in silty soil at crest of 1H:1V slope at milemarker 8 on Highway 250 (R12).
